AHWG TA#3–Spool Piece

Product: DRV80 Gen. 1

Topic/Problem: Spool Piece Replacement Need

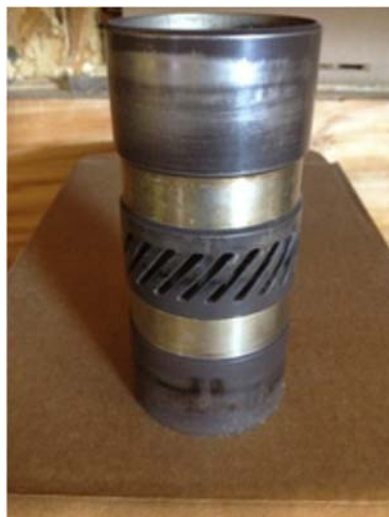
It has been asked on numerous occasions and not explicitly stated anywhere the necessity or lack thereof to replace the Spool Piece (DRV80 Gen. 1 – p/n D8405) used within DRV80 Gen. 1 product. In many instances and applications the brown coating seen on new Spool Pieces gets rubbed off. This brown coating originally put on the spool piece is only from the manufacturing process used and is NOT part of the part design function intent (refer to Figure 1 below).

This aforementioned rubbing is normal wear and will still allow the product to function as designed. The only need or reason to replace a Spool Piece would be if it were to be dropped resulting in physical damage to the structure; i.e. a bent or cracked edge or member.

Figure 1: Spool Piece Wear

If you are ever installing a new Spool Piece on to the drive mechanism please ensure that you are following the replacement procedure described in ***AHWG TSB#2-Drive Mech Motor Error Replacement***, specifically ensuring the 5/16" lock nut is torqued to 80-90 in-lb (step 11).

This Spool Piece is NOT a warranty replacement item as it is considered to be a wear item that should never need replacement.
