HOT WATER SUMMARY

Locations: Hampton Inn - Tamarac, FL

Nests: Domestic HW

DRV80
DRV

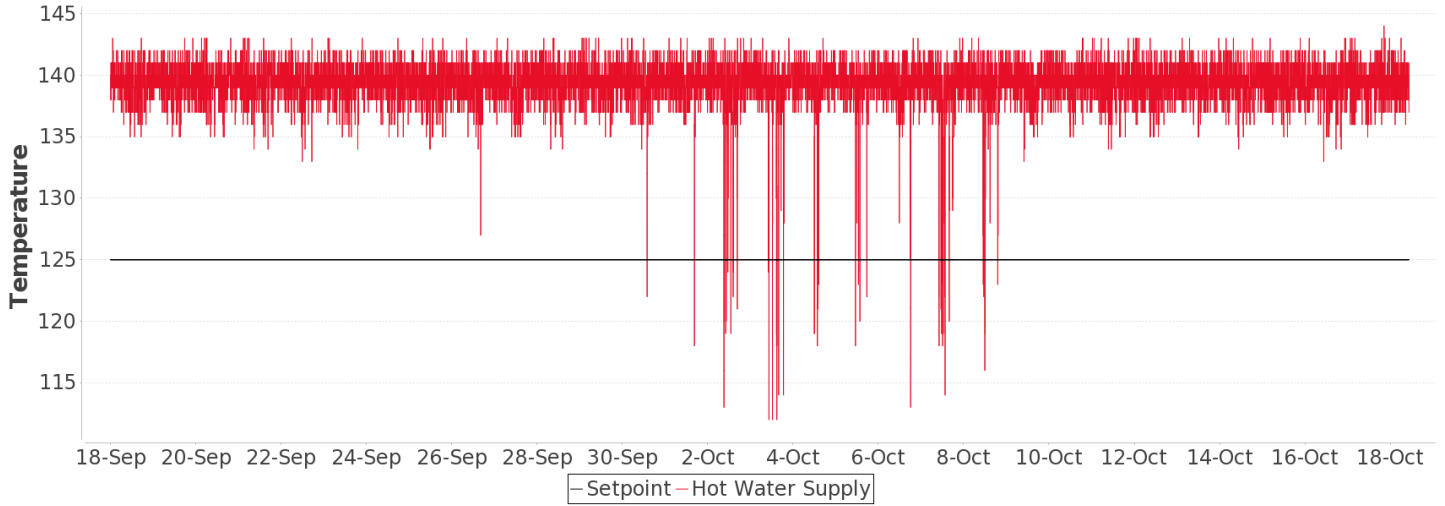
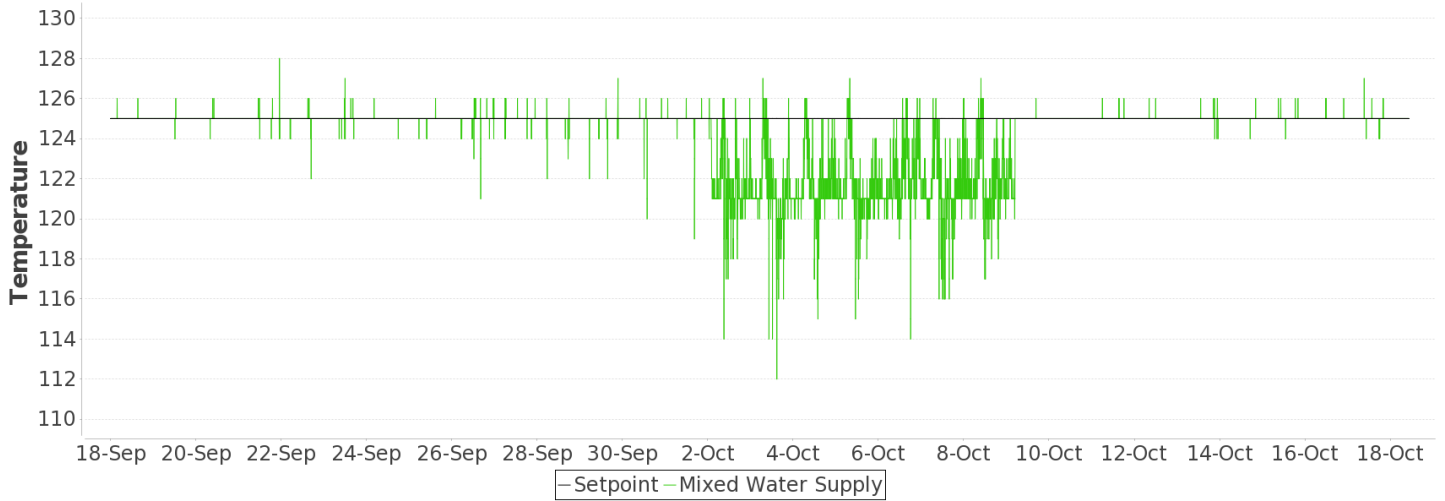
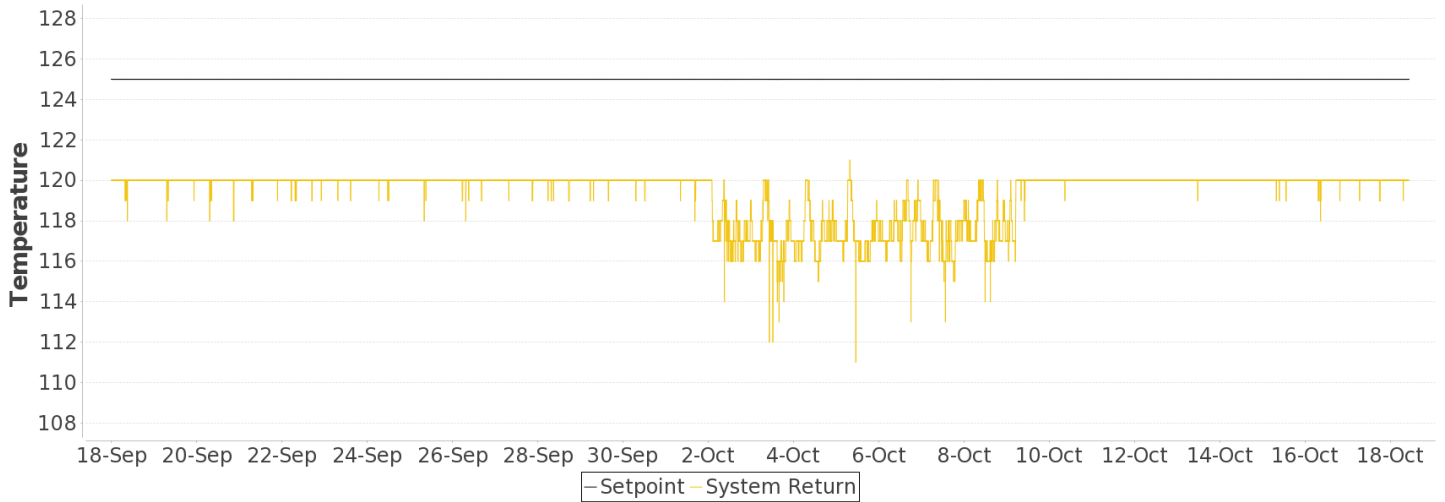
System Performance Record

Setpoint		125 °F	
Mixed Water Supply	112 °F	124 °F	128 °F
System Return	111 °F	119 °F	121 °F
Hot Water Supply	112 °F	139 °F	144 °F
	Minimum	Average	Maximum

167 Alerts

Description	Count	% of Total
Hot Water Supply Low	104	62%
Hot Water Supply Below Setpoint	58	35%
Mixed Water Supply Low	5	3%
	167
